Manhole Inspection Summary

Manhole # S19EE2020MH

Insp Date: **9/19/06 2:46 PM**

Location Address: **1501 NEWBURY ST**

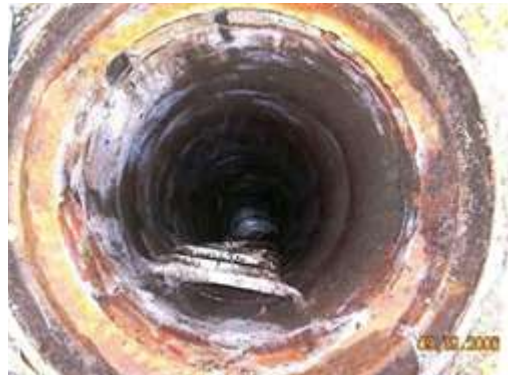
Top View

Adjustment and Barrel infiltration.
Corroded steps.

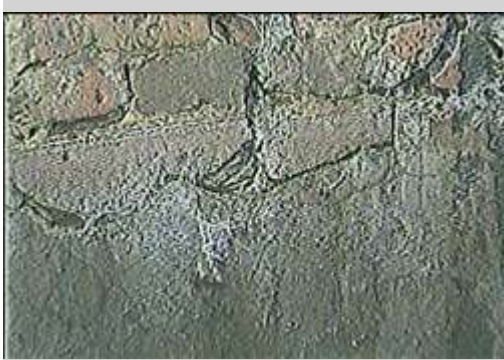
Defect

Adjustment deterioration, infiltration, and cracks.

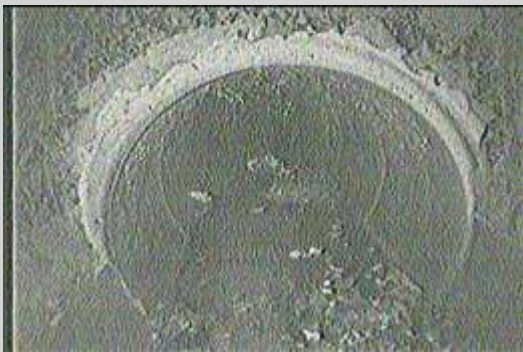
24 in. Circular Gravity Sewer Pipe Out @ 12 O'Clock

Deposits: ☐ None ☐ Mud ☐ Sludge ☒ **Debris** ☐ Grease

Silt Depth: **0.5** (in.) Deposits Extent: **Light**

Infiltration: **None** Pipe Seal Cond: **Unknown**

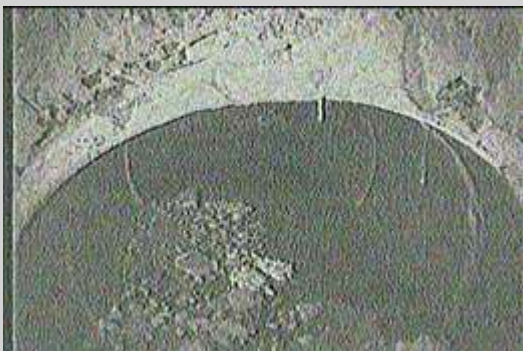
24 in. Circular Gravity Sewer Pipe In @ 6 O'Clock

Invert Depth: **17.85** (ft.) Flow Characteristics: **Slow**

Deposits: ☐ None ☐ Mud ☐ Sludge ☒ **Debris** ☐ Grease

Silt Depth: **0.5** (in.) Deposits Extent: **Light**

Infiltration: **Evidence** Pipe Seal Cond: **Unknown**
